UAVs in the Inspection of Aircraft

N P AVDELIDIS

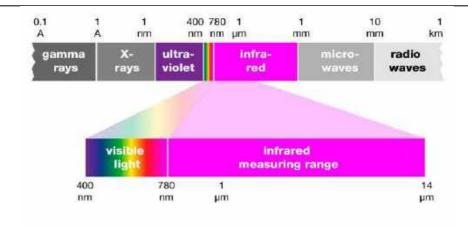
IR thermal vision is the capability to detect and measure by artificial means, the IR radiation that all bodies with temperature above 0 K emit.

IR vision is aided by computer sciences to process the acquired information.

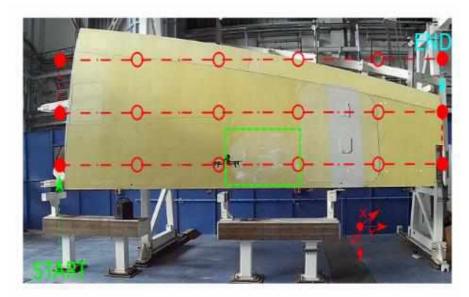
Fig. 5. Automated aerial wing inspection using 18 waypoints.

- •Inspection time with respect to the surface length between 1hr 4hr
- •Non Linear guidance law
- •The UAV follows a waypoint algorithm and inspects specific points of the sample in order to get full coverage

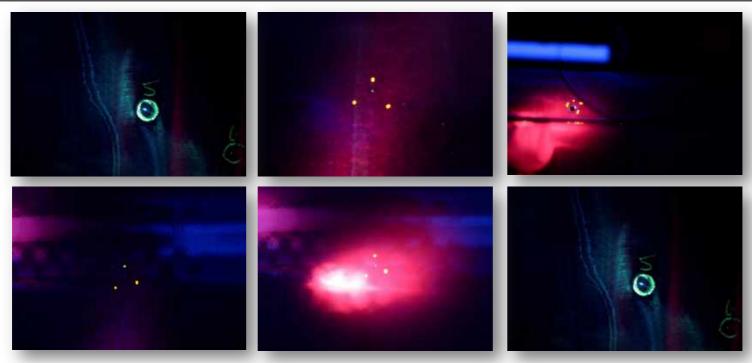
11 images from 4 possible defects were chosen as the baseline

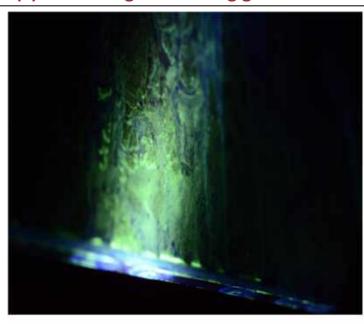
(a) Initial Image containing green areas

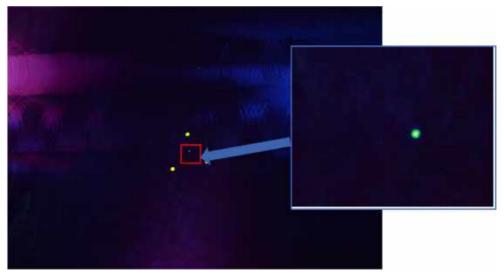
- Dataset for testing contains 119 images
- ➤ 25 images of 4 possible defects
- > Algorithm classifies correct all 25 images defects plus one

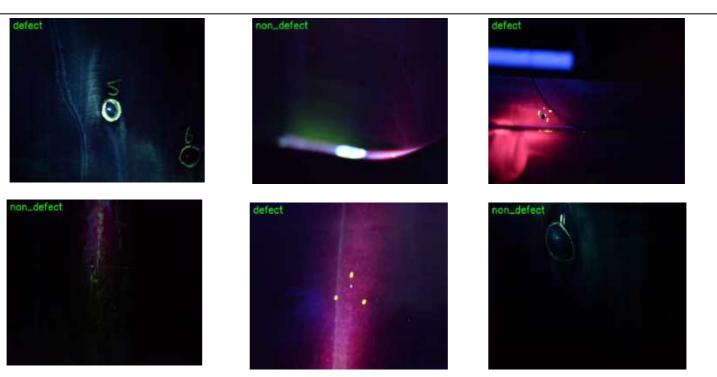
Results from Random Forest (5 correct 1 wrong (bottom right))

- > A Random forest algorithm was implemented
- > Trained on the image dataset (total 133, 30 images with defects, 103 non defects)
- Features for training, colour and texture
- ➤ Results: Accuracy 96%
- > Indication that the Random forest approach may work but the dataset is very small

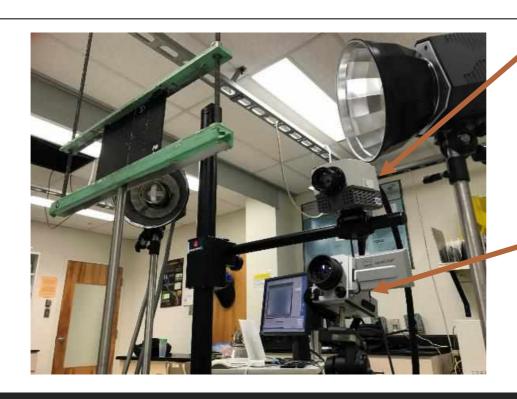
Cooled Camera (FLIR Phoenix)

• Spectral Range: 3-5 μm

Pixels: 640*512

• Frame Rate: 50Hz.

Uncooled Camera

(Jenoptik variocam hr)

• Spectral Range: 7.5-14 μm

• Pixels: 640*480

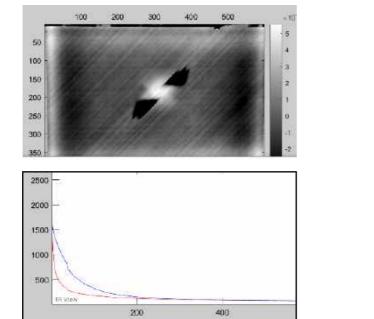
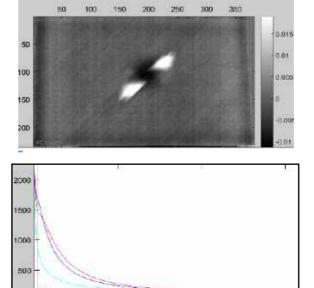
Specimen: 24J impact Damage. Data captured from Rear

Cooled Camera is more sensitive, however the uncooled camera captures sufficient data

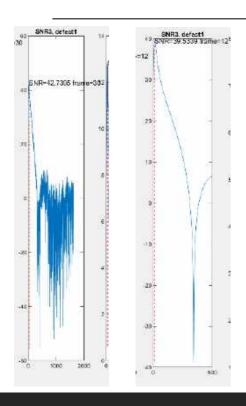
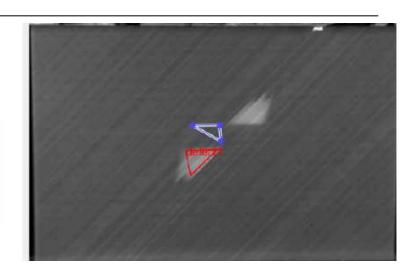
Cooled Camera Data - Signal-to-Noise Ratio

Thermographic Signal Reconstruction

$$SNR_3 = 10 \log_{10} \frac{|\mu_S - \mu_N|^2}{\sigma_N^2}$$

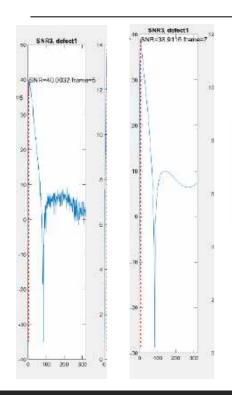
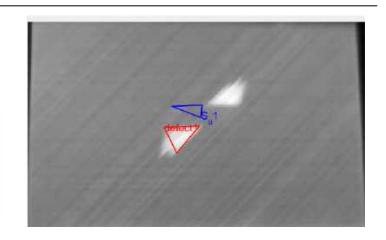
Uncooled Camera Data - Signal-to-Noise Ratio

Thermographic Signal Reconstruction

$$SNR_3 = 10 \log_{10} \frac{|\mu_S - \mu_N|^2}{\sigma_N^2}$$

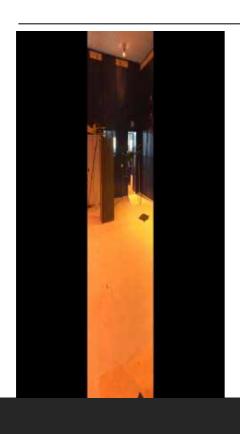
Manually flying a UAV will capture significantly noisy data, that is essentially useless when subject to standard post-processing procedures. This is due to the images being captured at different distances/angles and also the atmospheric interreference. To reduce the noise, the UAV needs to be localised.

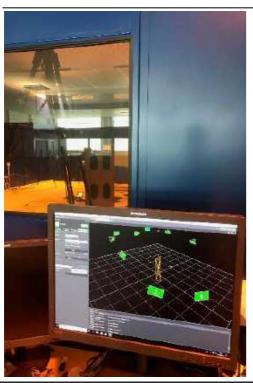
The UAV is positionally tracked using a Vicon system, this data is then fed back into the UAV's flight controller so the UAV can localise itself and remain stable, using an algorithm the UAV can be commanded where to fly automatically, allowing a safe and

stable inspection.
